Field Service Bulletin No. 55

ADC Compact
Type 5145 / 100/101/140

Path Speed CR MP3010
Type 5145 / 200/201/240

Replacement of a broken light barrier flag at the Cassette Opener

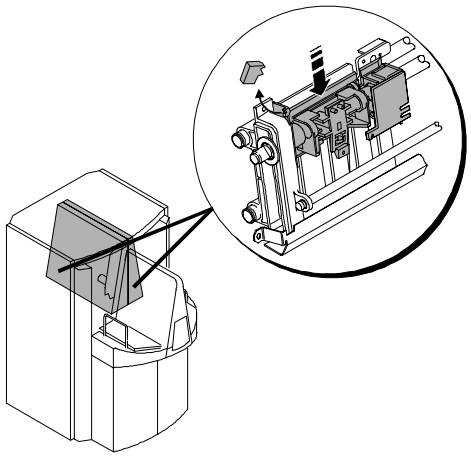
Symptom
The light barrier flag (see figure beside) of the cassette opener of module 1 or 2 may break when it touches the frame of the cassette opener.

Reason
The cassette opener (LHS) remains in the home position and is not moved to the middle position when the cassette holder is lowered manually.

Solution
Exchange the broken part.
Order number: **CM+9.5146.5911.0**

Spare part can be ordered separately. It is not necessary to order a complete cassette opener!
